Release Notes

Polycom® HDX Systems, Version 2.5.0.7_G

Polycom is pleased to announce the latest release of Polycom HDX hardware and software. This document provides the latest information about version 2.5.0.7_G software for Polycom® HDX series systems.

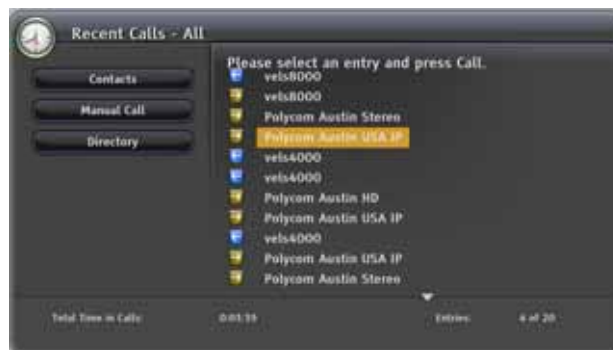
Recent Calls Screen

The Recent Calls screen has been redesigned with functionality similar to the Contacts home screen.

From the Recent Calls screen you can navigate to the Contacts list screen, Place a Call screen, or the directory. You can also add recent calls to your Contacts list.

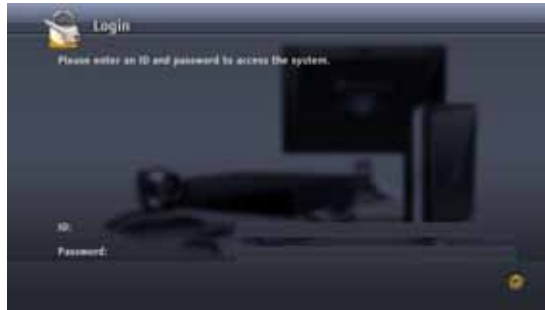
Login and Logout

In version 2.5 you can require users to log in for system access. Version 2.5 also adds a logout feature. If **Require Login for System Access** is enabled, the system automatically prompts users to log in when the system comes out of sleep mode. If a call comes in, the user must log in before answering the call, even if the system is configured to answer calls automatically.

When you log in, the system displays the time and date of the last successful login to the account, along with the number of unsuccessful login attempts since that time.
